## CONSUMER PRODUCTS TECHNICAL BULLETIN

**Date:** February 29, 2012  
**Product:** 20-163 Mobile/Base Triple Trunking Scanner  
**Subject:** CPU Firmware Update Reworking Procedure  
**Target Date Code:** 08A11, 10A11, 11A11

### Firmware Version 1.09 Problem

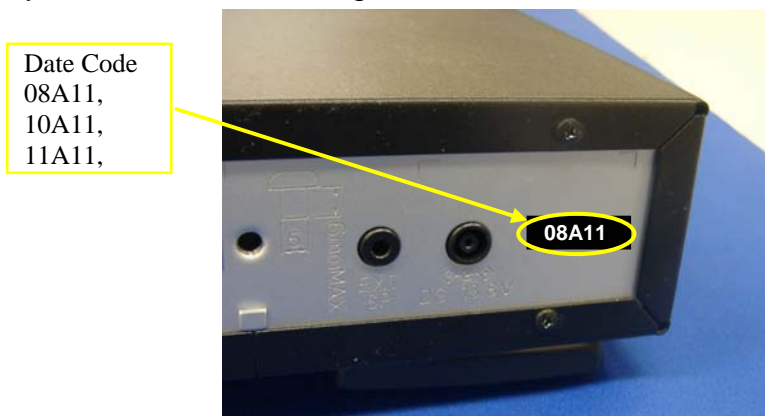
- 1.2 Note: you can confirm the target date code as shown in the following photo.
