CONSUMER PRODUCTS TECHNICAL BULLETIN

Date: February 29, 2012
Product: 20-164 Handheld Triple Trunking Scanner
Subject: CPU Firmware Update Reworking Procedure
Target Date Code: 08A11, 09A11, 10A11, 12A11, 01A12

Firmware Version 1.09 Problem

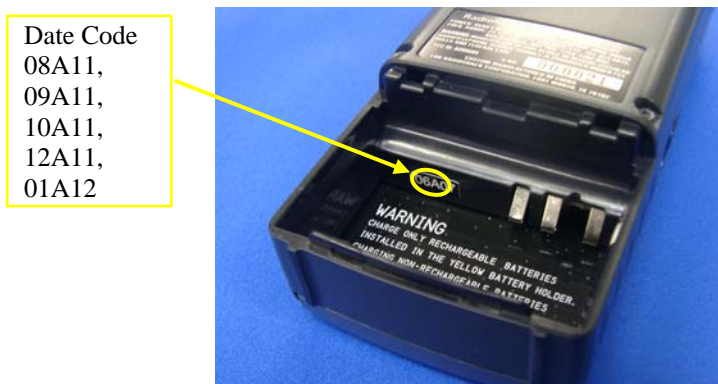
- 1.2 Note: you can confirm the target date code as shown in the following photo.
