Broken, Abandoned, and Forgotten Code, Part 4

Author: Zachary Cutlip

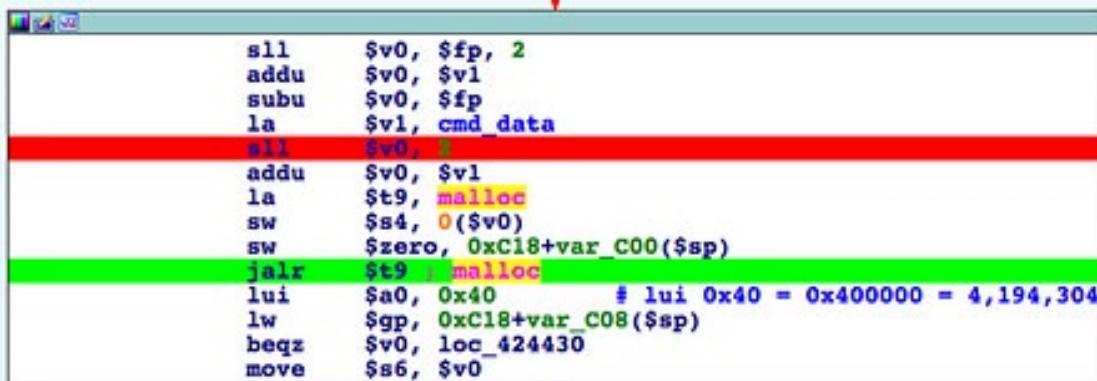
960) (718,804) 00023C18 00423C18: sa_parseRcvCmd+4A4

It turns out, the problem isn't with the base64 decoder, but something more obvious. The problem is with the buffer that the firmware gets decoded into.

```
sll    $v0, $fp, 2
addu   $v0, $v1
subu   $v0, $fp
la     $v1, cmd_data
sll    $v0, $v1
addu   $v0, $v1
la     $t9, malloc
sw     $s4, 0($v0)
sw     $zero, 0xC18+var_C00($sp)
jalr   $t9, malloc
lui    $a0, 0x40          # lui 0x40 = 0x400000 = 4,194,304
lw     $gp, 0xC18+var_C08($sp)
beqz   $v0, loc_424430
move   $s6, $v0
```
