# Flash 7000 Installation Manual

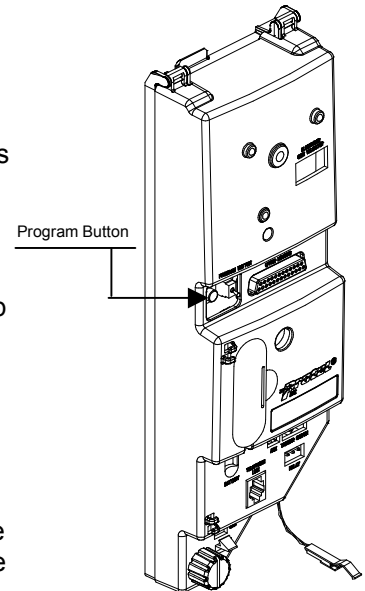
### Enter the Program Mode

- Locate the **program button** access hole on the chassis assembly just under the terminal block connector.
- With the phone on hook, press and hold down the programming button.
- While still pressing the button, lift the handset off hook.
- Listen in the receiver for a single beep. When the beep is heard, release the button.

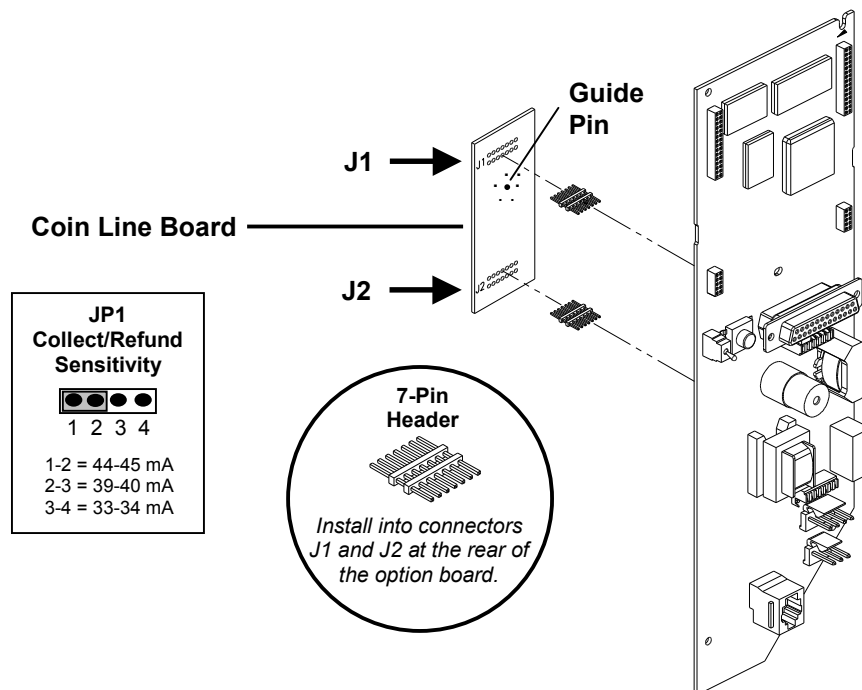
7. Mount the coin line option board to the rear of the chassis assembly such that the 7-pin header attached to connector **J1** of the option board installs into the holes that correspond to connector **JD1** at the rear of the chassis assembly (the letter designation **JD1** can only be viewed from the front of the chassis assembly.) The 7-pin header attached to connector **J2** on the option board should align into the holes that correspond to connector **JD2** at the rear of the chassis assembly. The guide pin attached to the rear of the coin line board should align into the guide hole at the rear of the chassis.

8. Secure chassis PCB to the chassis housing.
9. Reinstall the chassis assembly into the lower housing.
10. Reinitialize the phone. Then, secure the upper and lower housings of the phone together.

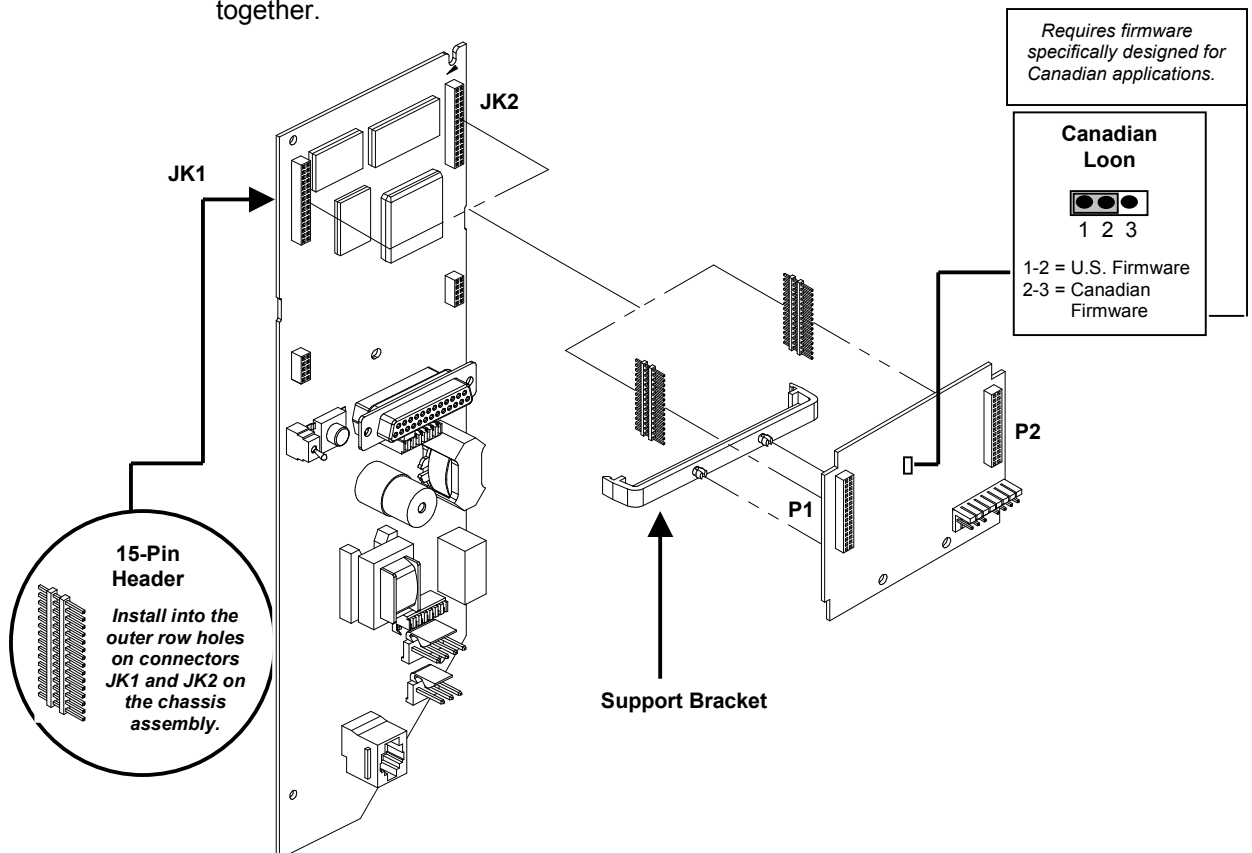
6. Mount the ECS option board to the front of the chassis assembly such that the headers attached at connectors **JK1** and **JK2** install into the outer most holes of connectors **P1** and **P2** of the option board. Then, secure the option board support bracket to the chassis assembly.

7. Reinstall the chassis.
8. Reinitialize the phone. Then, secure the upper and lower housings of the phone together.

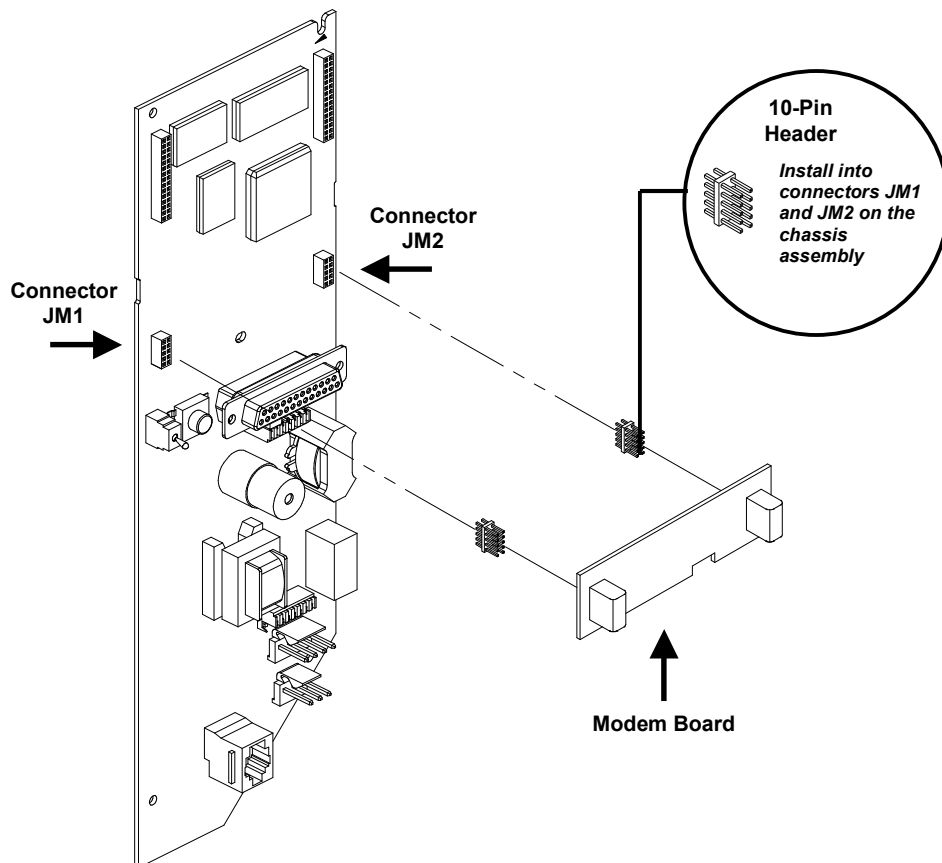
6. Mount the modem option board to the front of the chassis PCB such that the headers attached to connectors **JM1** and **JM2** at the rear of the option board install into the holes that correspond to connectors **JM1** and **JM2** on top of the chassis PCB assembly.

7. Reinstall the chassis housing.
8. Reinitialize the phone. Then, secure the upper and lower housings of the phone together.

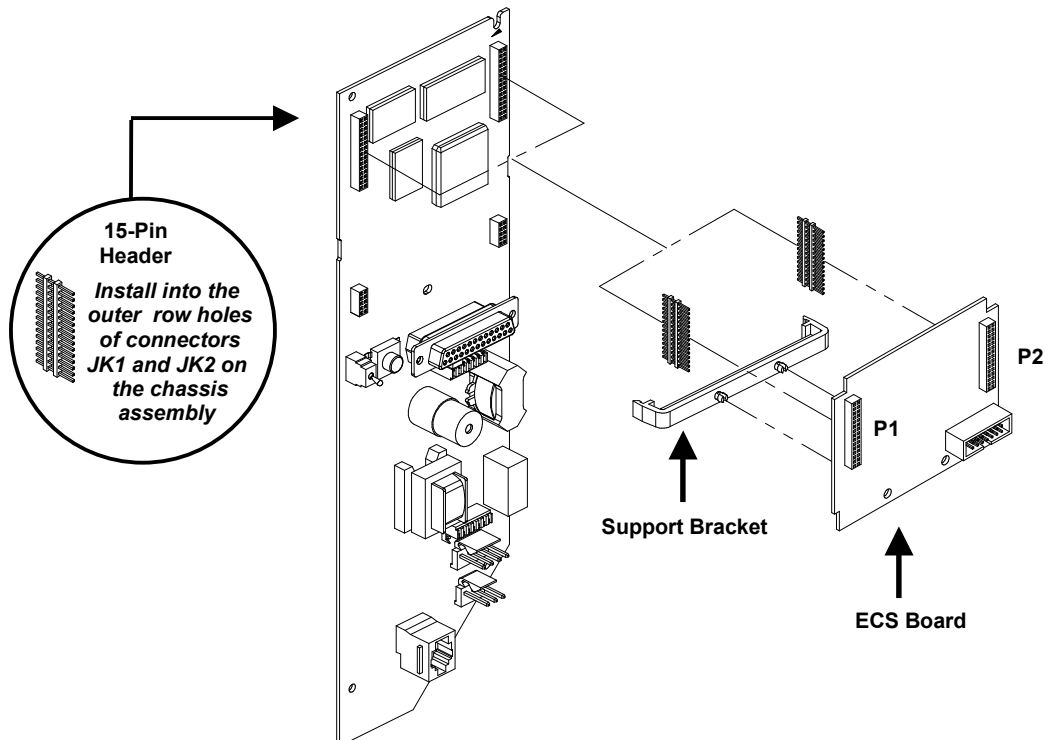
6. Mount the ECS option board to the front of the chassis assembly such that the headers attached at connectors **JK1** and **JK2** install into the outer most holes of connectors **P1** and **P2** of the option board. Then, secure the option board support bracket to the chassis assembly.

7. Reinstall the chassis.
8. Reinitialize the phone. Then, secure the upper and lower housings of the phone together.

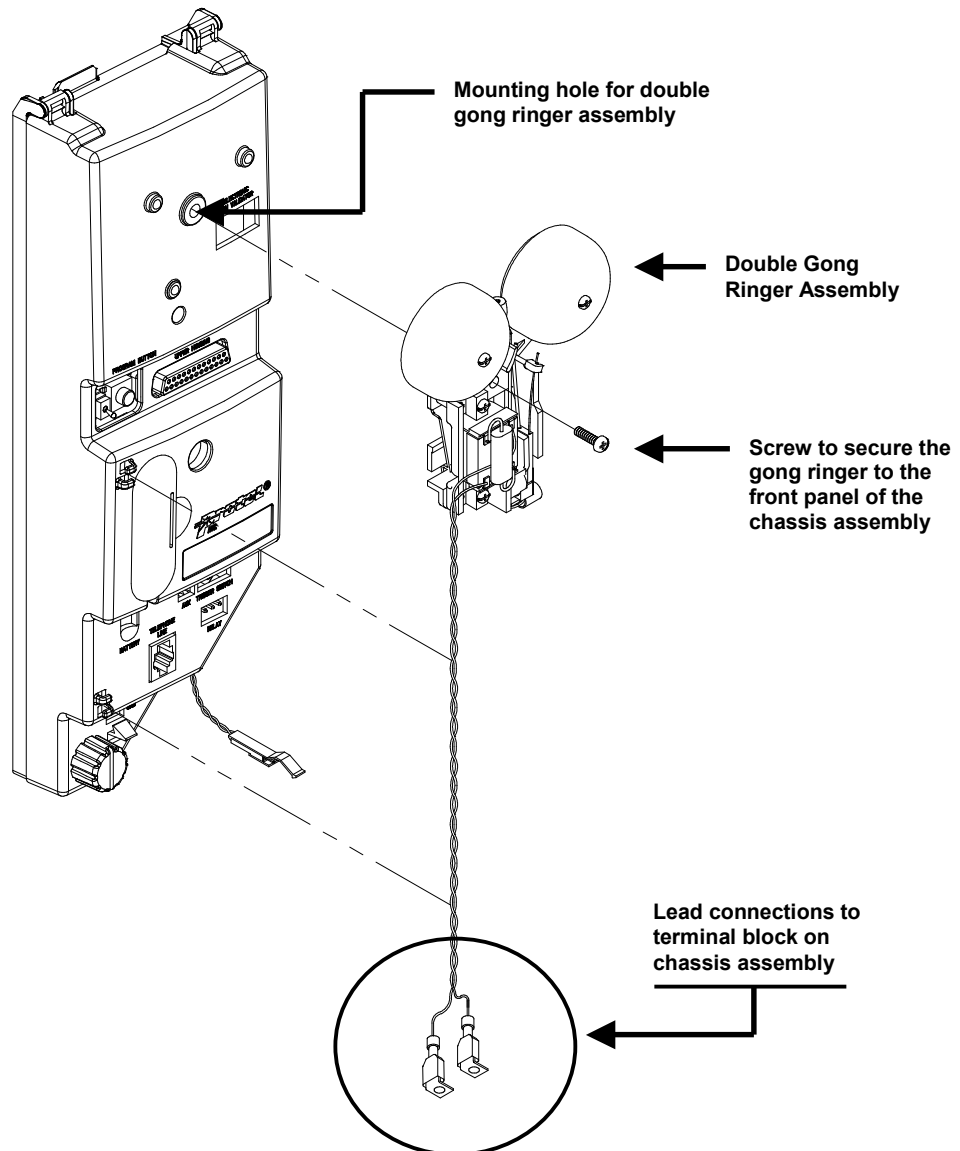
# Appendix M - Installing the Double Gong Ringer

1. Mount the double gong ringer assembly to the front cover of the chassis assembly such that the ringer assembly mounting screw is aligned with the ringer mounting hole on the front cover of the chassis assembly.
2. Secure the gong ringer to the front of the chassis assembly.
3. Connect the RED lead extending from the gong ringer to the "ring" connection on the lower housing's terminal block.
4. Connect the GREEN lead extending from the gong ringer to the "tip" connection on the lower housing's terminal block.
5. Disable the original piezo electric ringer by having the computer operator set the option labeled "Disable Piezo Ringer" to YES in the Options & Registers record used by the phone. The next time the phone is polled, the piezo ringer will be disabled.
